Building With Tire Bales - Addressing Some Engineering Concerns

Leonard D. Jones, P.E.
Littleton, CO

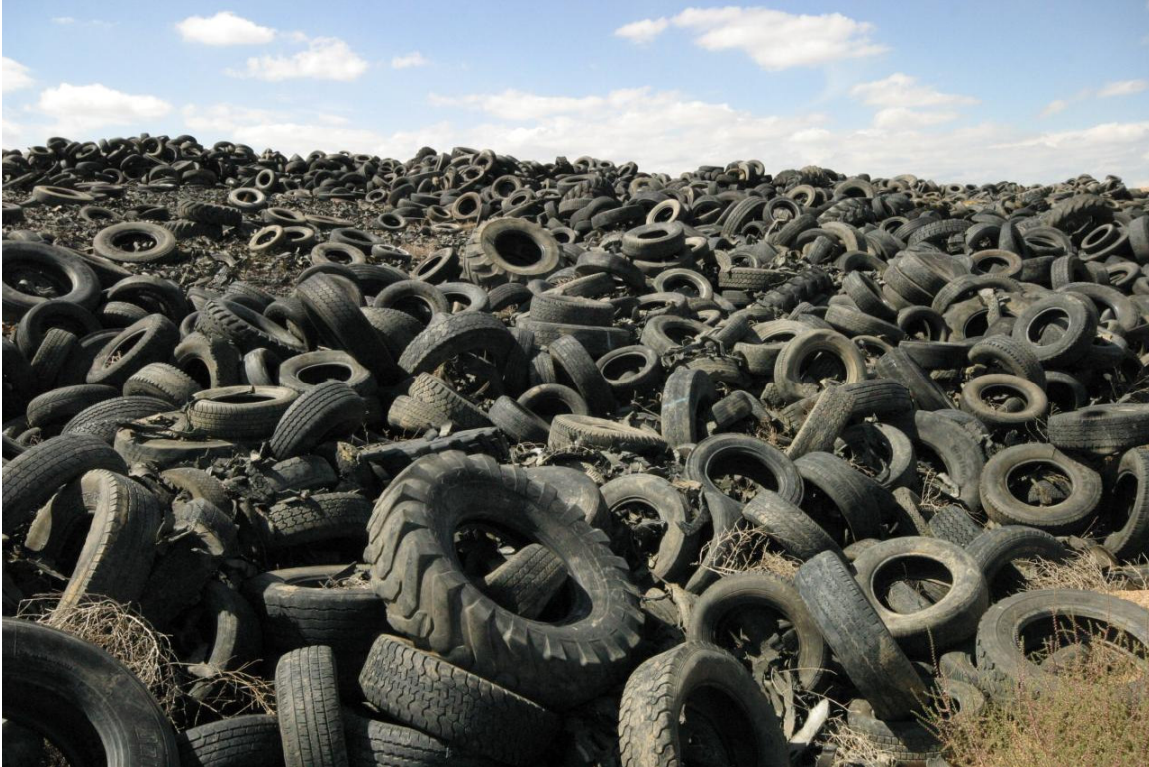
Acres and Acres of Tires – small part of a tire dump located near Fountain, Colorado. ¹

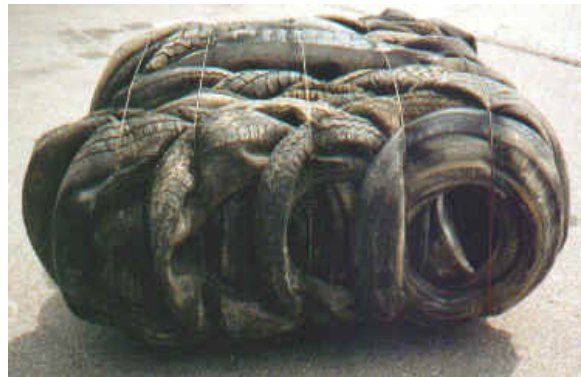
Figure 1 – A Typical Tire Bale

Tire bales are made by compressing waste tires into a rectangular shape with a large hydraulic press and banding them with with 5 or more, .115 inch diameter, galvanized or stainless steel wires. The bales are typically 5 feet wide x 5 feet long x 2.5 feet high, although sizes can vary depending on the particular press that is used. Smaller half bales are also available. One bale requires approximately 100 passenger car and/or recreational vehicle tires. Each full bale weighs approximately one ton. The bales, when stacked in running bond and finished with a cement-based grout and plaster/stucco have the potential of forming a strong, stable wall. Pictures of a typical tire bale and a tire bale press are shown at Figures 1 and 2.

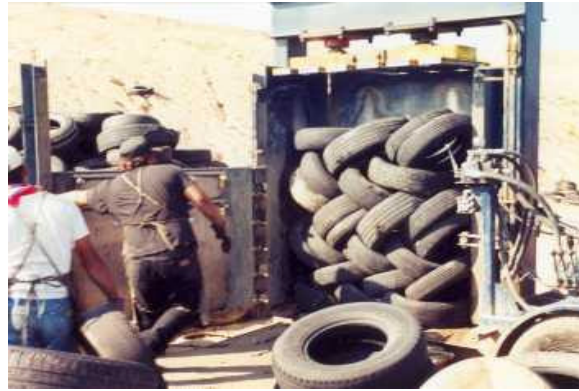
Figure 2 – Hydraulic Tire Press

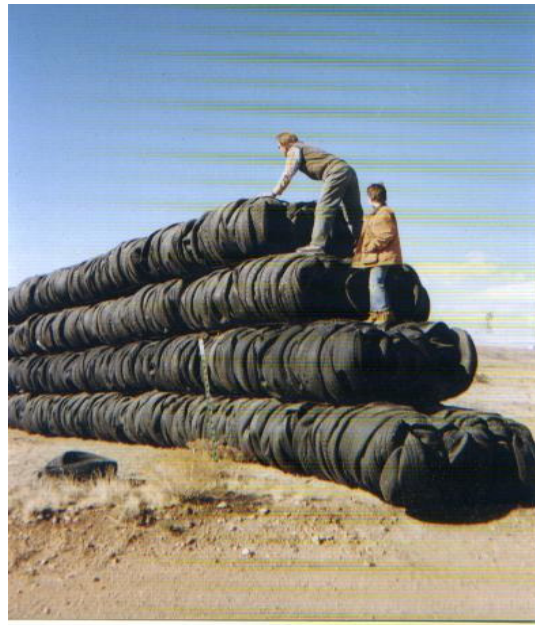
Figure 4 – Four-High Bale Wall

Tire bales should be laid in running bond, as if they were very large bricks, as shown in Figure 4. Wire straps wrapping bales shall be located running with the length of the wall, so as to butt end to end. Corners, where necessary, should be made at even block spacing, with half-blocks every other course to maintain the running bond pattern. For passive solar house designs, it may be preferable to construct the North wall as a single unit with staggered ends, butting N-S walls up against the North wall. Where this is done, the N-S wall should be joined to the North wall with a pattern of 3 - #4 rebars each way at each course of tire bales. These details are shown in attached Figure 5 below:
