Building With Tire Bales - Addressing Some Engineering Concerns

Leonard D. Jones, P.E.
Littleton, CO

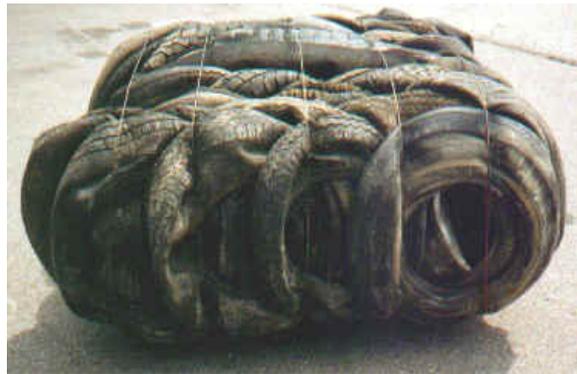
Figure 1 – A Typical Tire Bale

Tire bales are made by compressing waste tires into a rectangular shape with a large hydraulic press and banding them with with 5 or more, .115 inch diameter, galvanized or stainless steel wires. The bales are typically 5 feet wide x 5 feet long x 2.5 feet high, although sizes can vary depending on the particular press that is used. Smaller half bales are also available. One bale requires approximately 100 passenger car and/or recreational vehicle tires. Each full bale weighs approximately one ton. The bales, when stacked in running bond and finished with a cement-based grout and plaster/stucco have the potential of forming a strong, stable wall. Pictures of a typical tire bale and a tire bale press are shown at Figures 1 and 2.

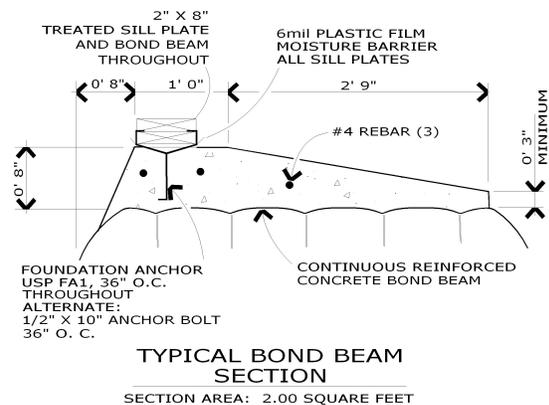
Figure 3 – Bond Beam Alternative

An adequate bond beam is required to support the roof beams, trusses, or rafters and to secure them to the walls. Experience suggests that this bond beam be constructed of reinforced concrete (3000 psi or greater) formed and poured in place on top of the wall. A nominal 6" x 24" or equivalent bond beam with 3 #4 rebars 10" on center all around is suggested. An alternative bond beam configuration is shown at Figure 3. Low slump concrete should be used so as to avoid losing too much concrete into the porous tire bales beneath the bond beam. The near-complete fit of the concrete into the bales will lock the bond beam into place. This may be supplemented by additional #4 rebars wired into the tire bales on 4 foot centers and tied into the horizontal reinforcing or by field fabricated anchors extending from beneath the final layer of tire bales.

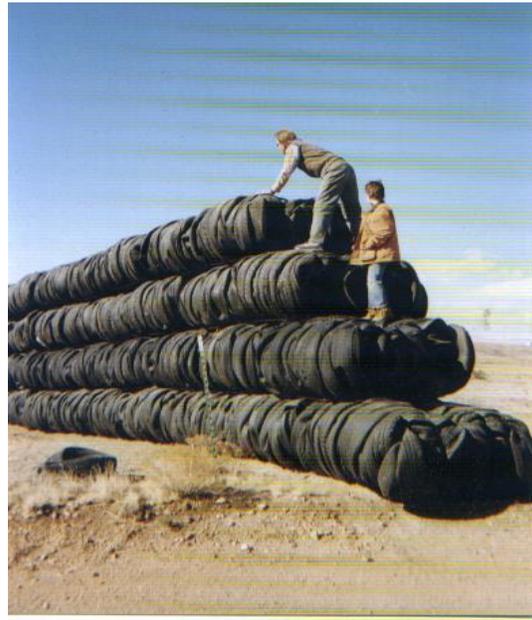
Figure 4 – Four-High Bale Wall

Tire bales should be laid in running bond, as if they were very large bricks, as shown in Figure 4. Wire straps wrapping bales shall be located running with the length of the wall, so as to butt end to end. Corners, where necessary, should be made at even block spacing, with half-blocks every other course to maintain the running bond pattern. For passive solar house designs, it may be preferable to construct the North wall as a single unit with staggered ends, butting N-S walls up against the North wall. Where this is done, the N-S wall should be joined to the North wall with a pattern of 3 - #4 rebars each way at each course of tire bales. These details are shown in attached Figure 5 below:

To my knowledge, experience with tire bales to date has only included single story structures with walls not exceeding 4 bales. I would not recommend higher walls or multi-story structures unless additional testing

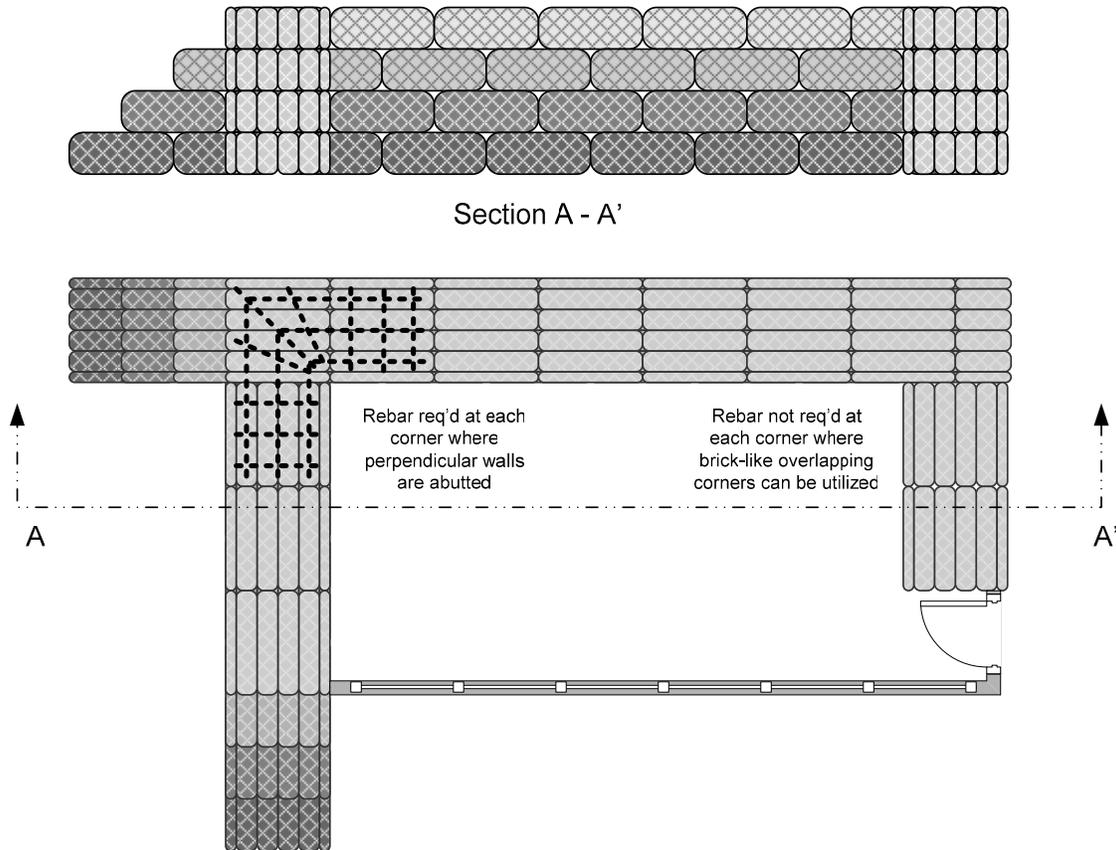
Figure 5 – Some Possible Tire Bale Wall Layout Features

Some possible tire bale layout features are shown in the sketch below:
